# Debris/Ice/TPS Assessment And Photographic Analysis For Shuttle Mission STS-40

July 1991

**Gregory N. Katnik**  
**NASA/Kennedy Space Center**

Shuttle Mission STS-40 was launched at 9:24 a.m. local 6/5/91

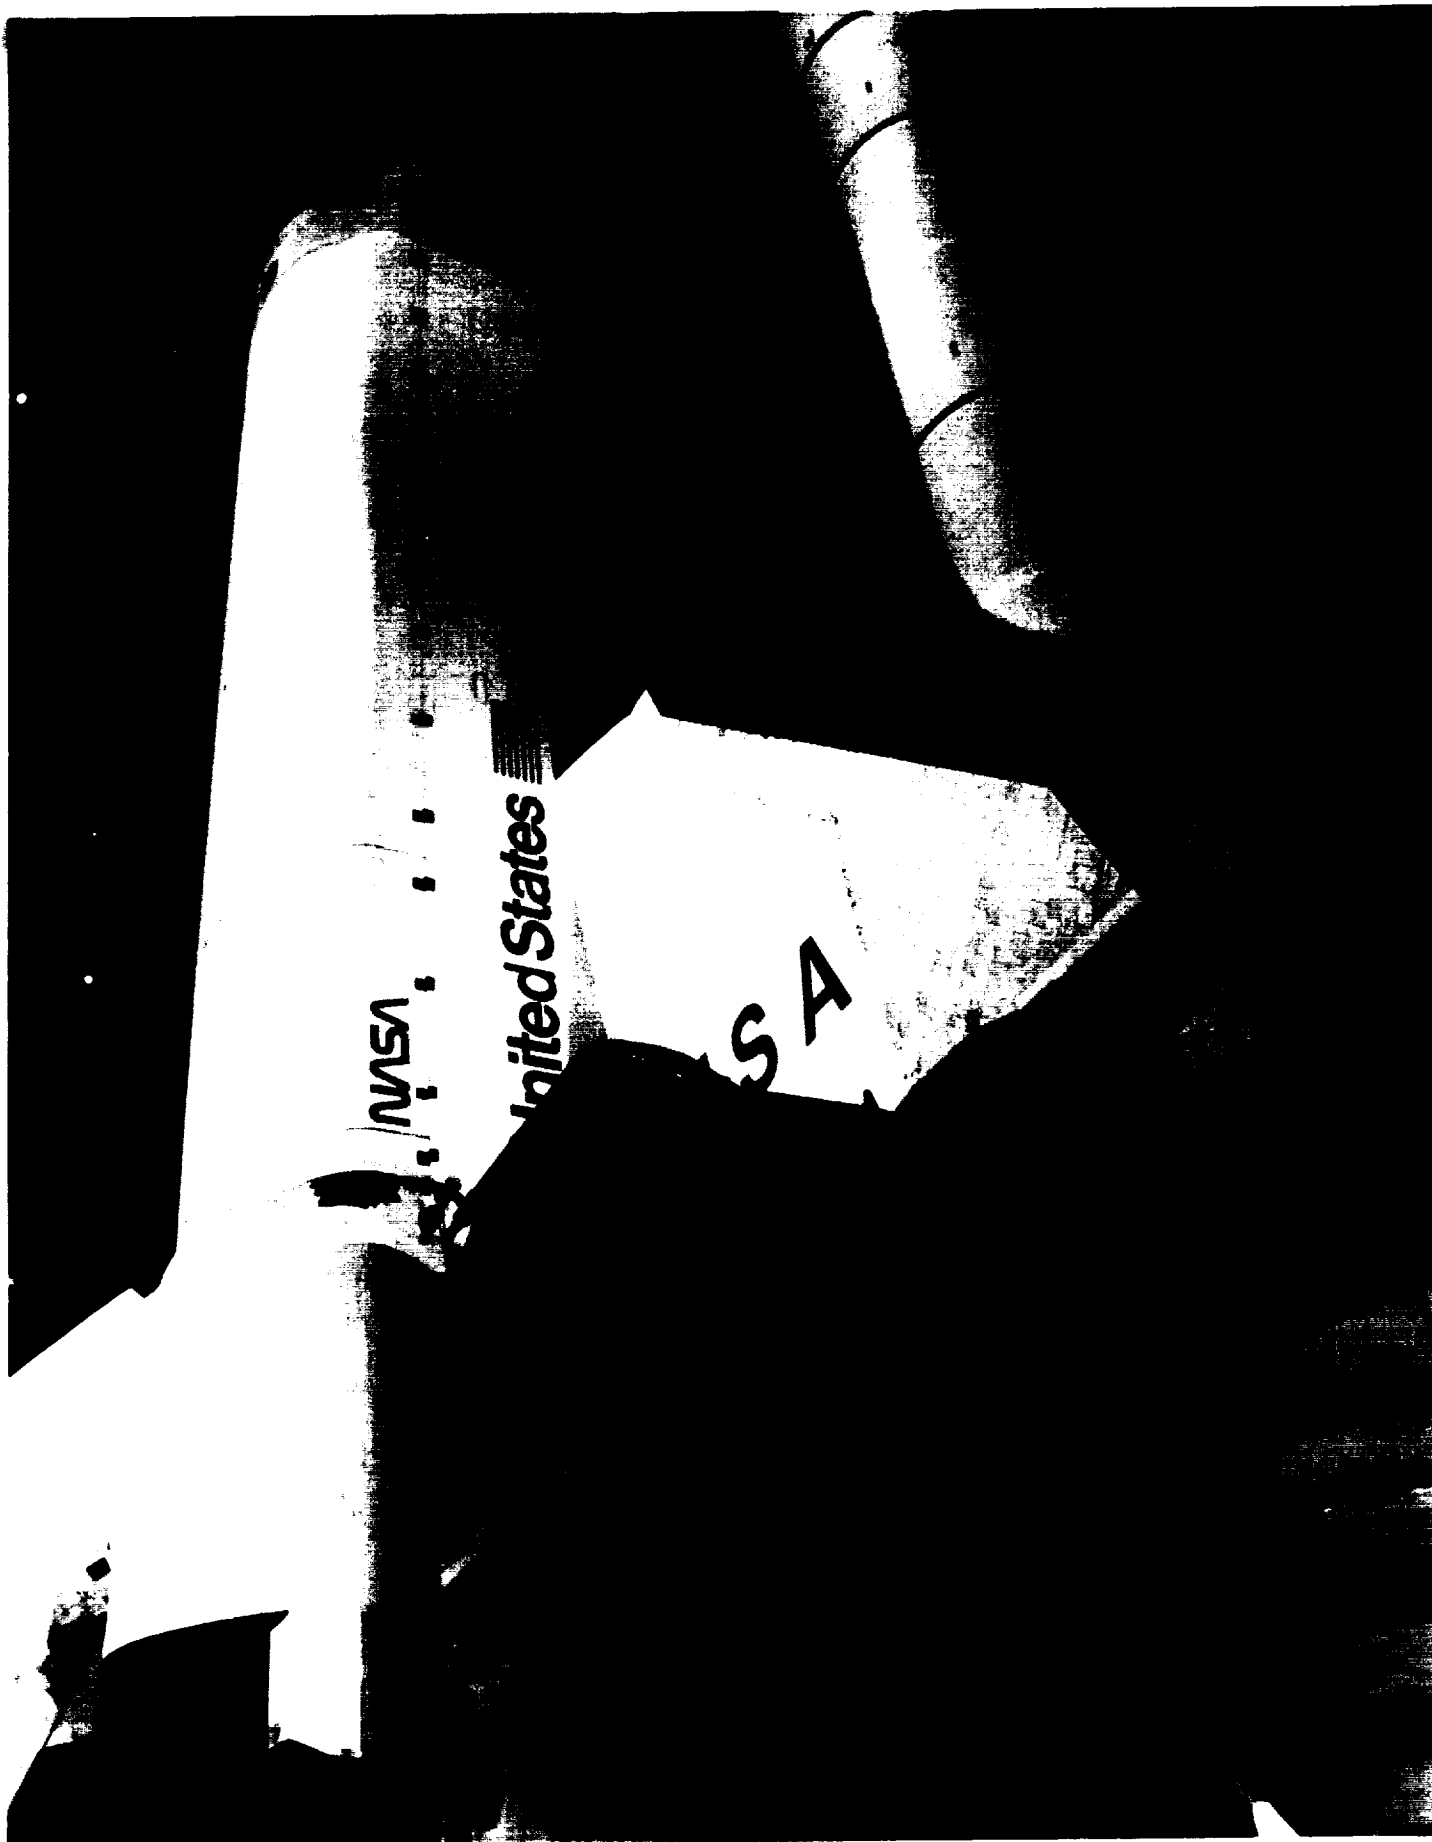
There was no ice/frost or TPS anomalies on the ET +Y+Z acreage

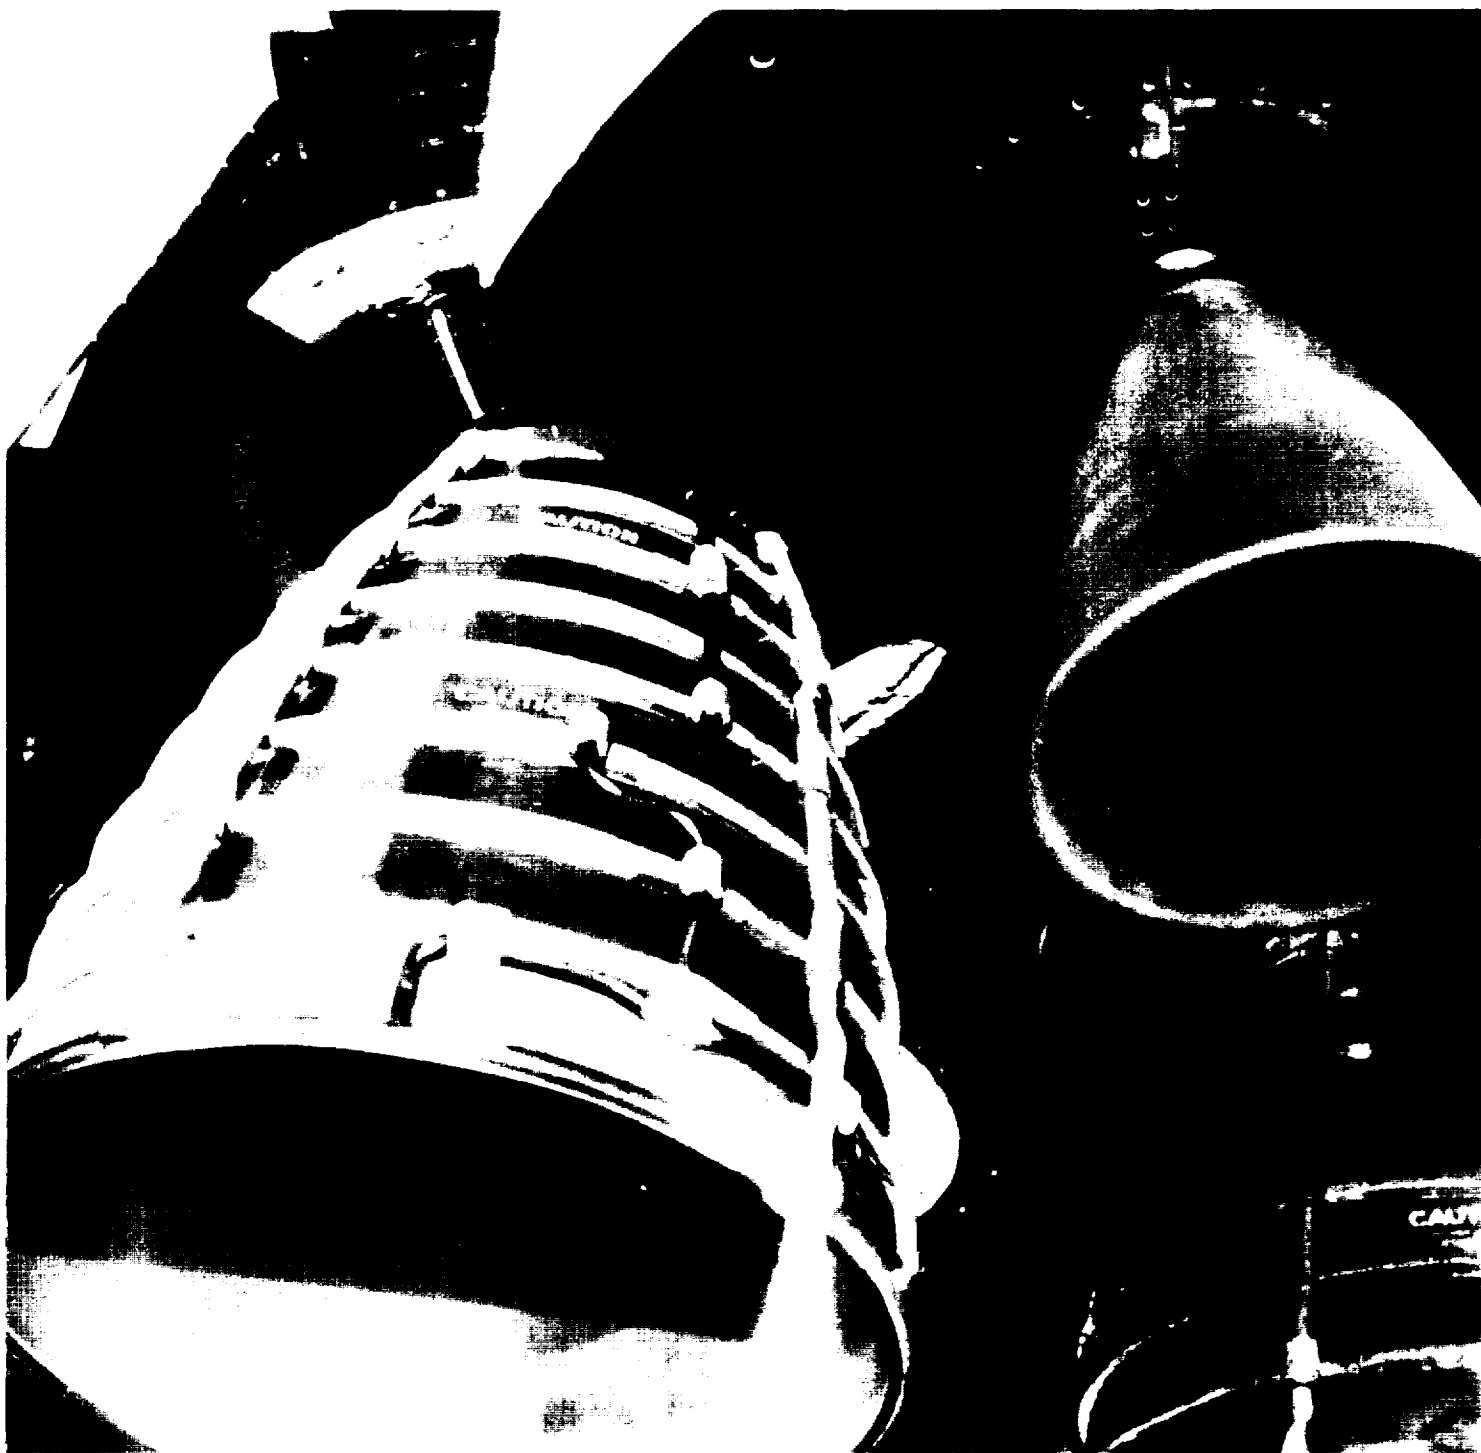
Light condensate was present on the SSME engine mounted heat shields. Light ice/frost had accumulated on the SSME #1 and #2 heat shield-to-nozzle interfaces.

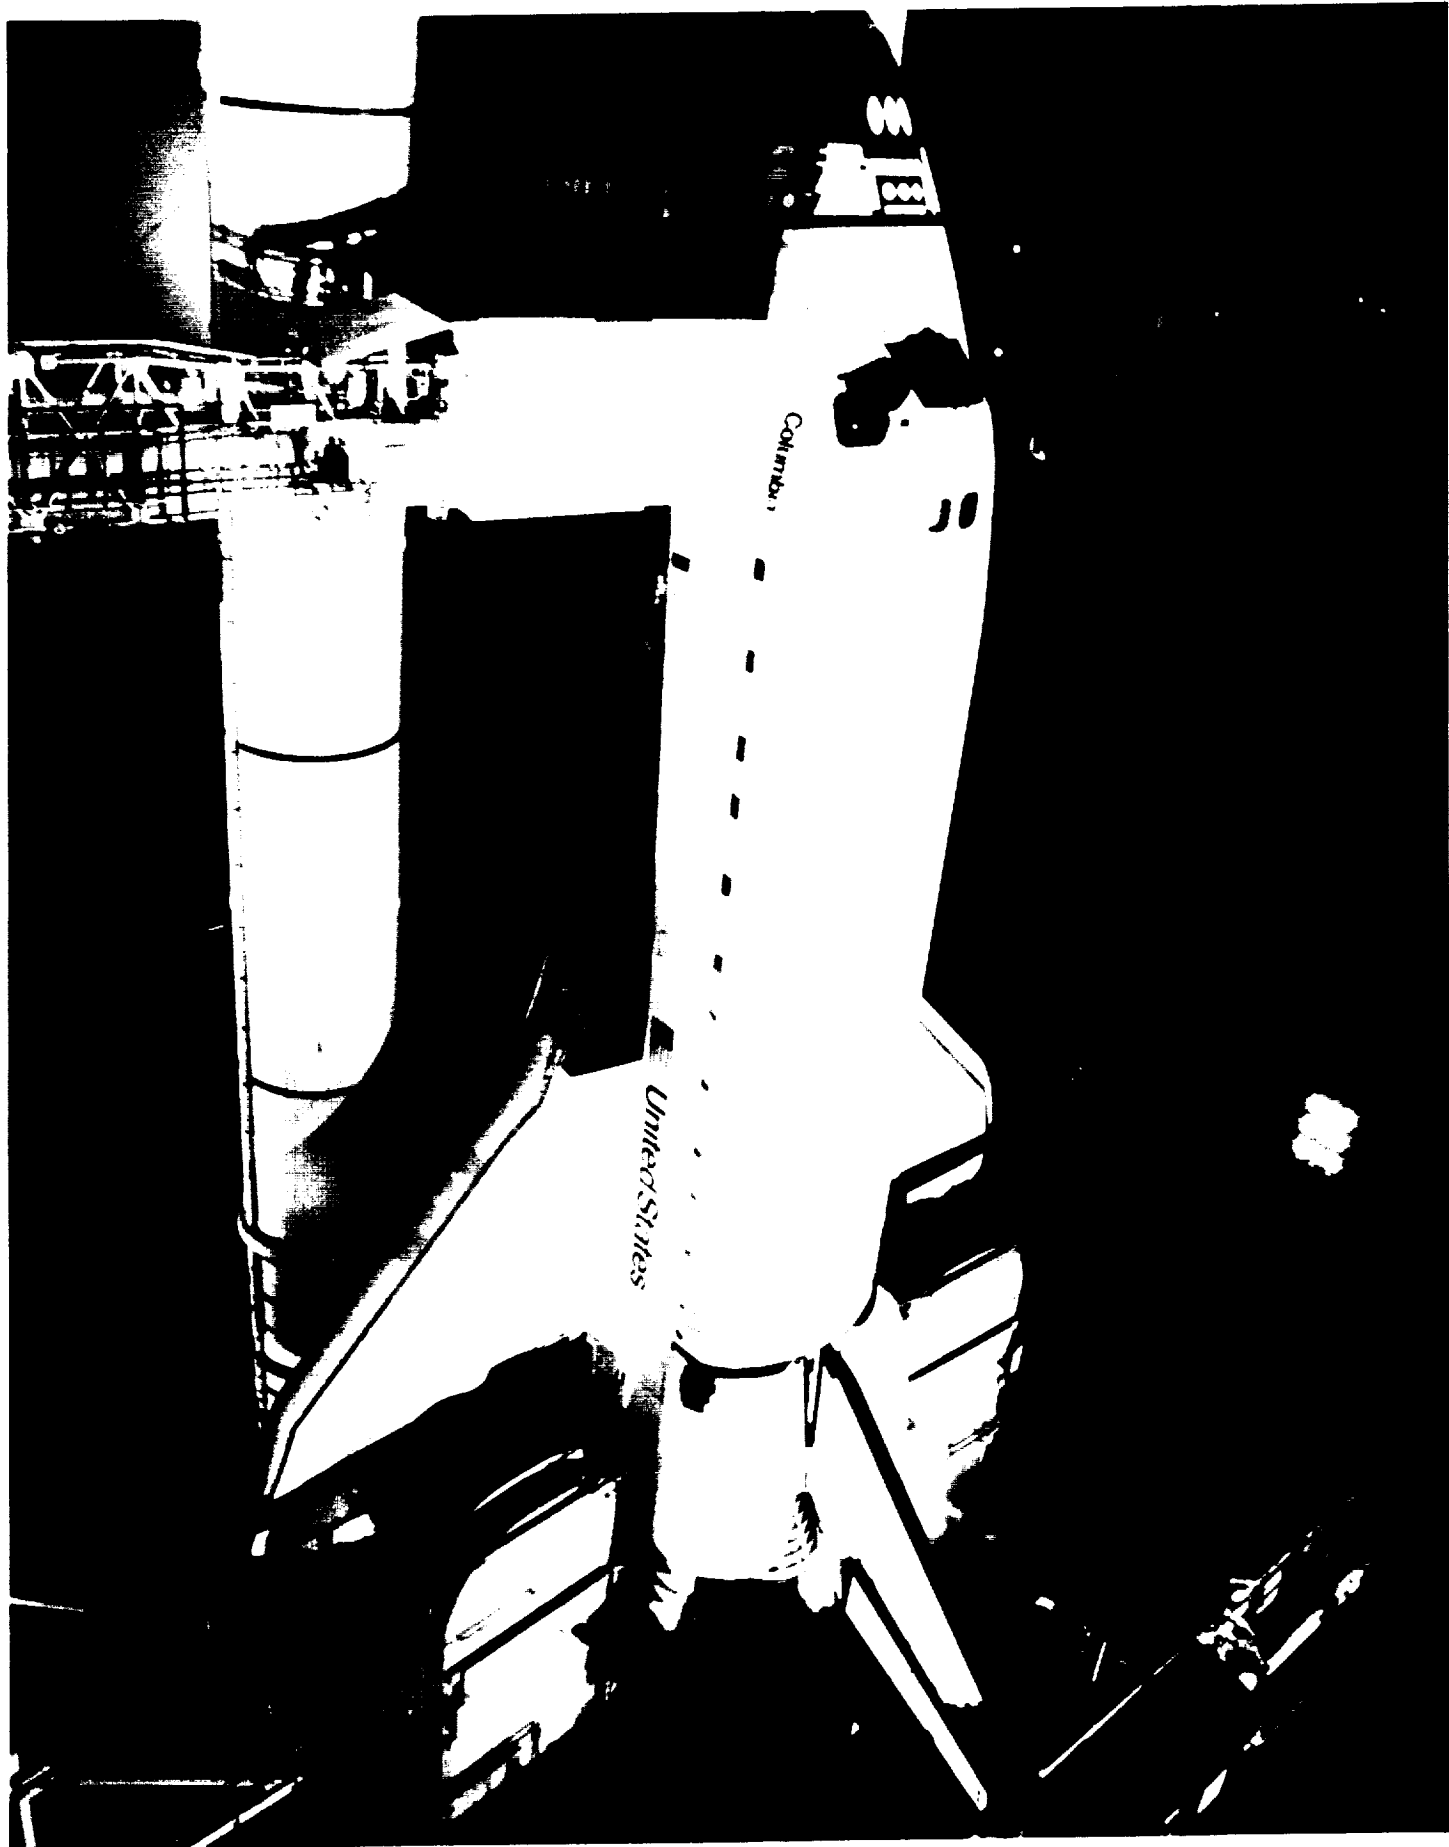
TPS and RCS paper covers on OV-102 were in proper configuration

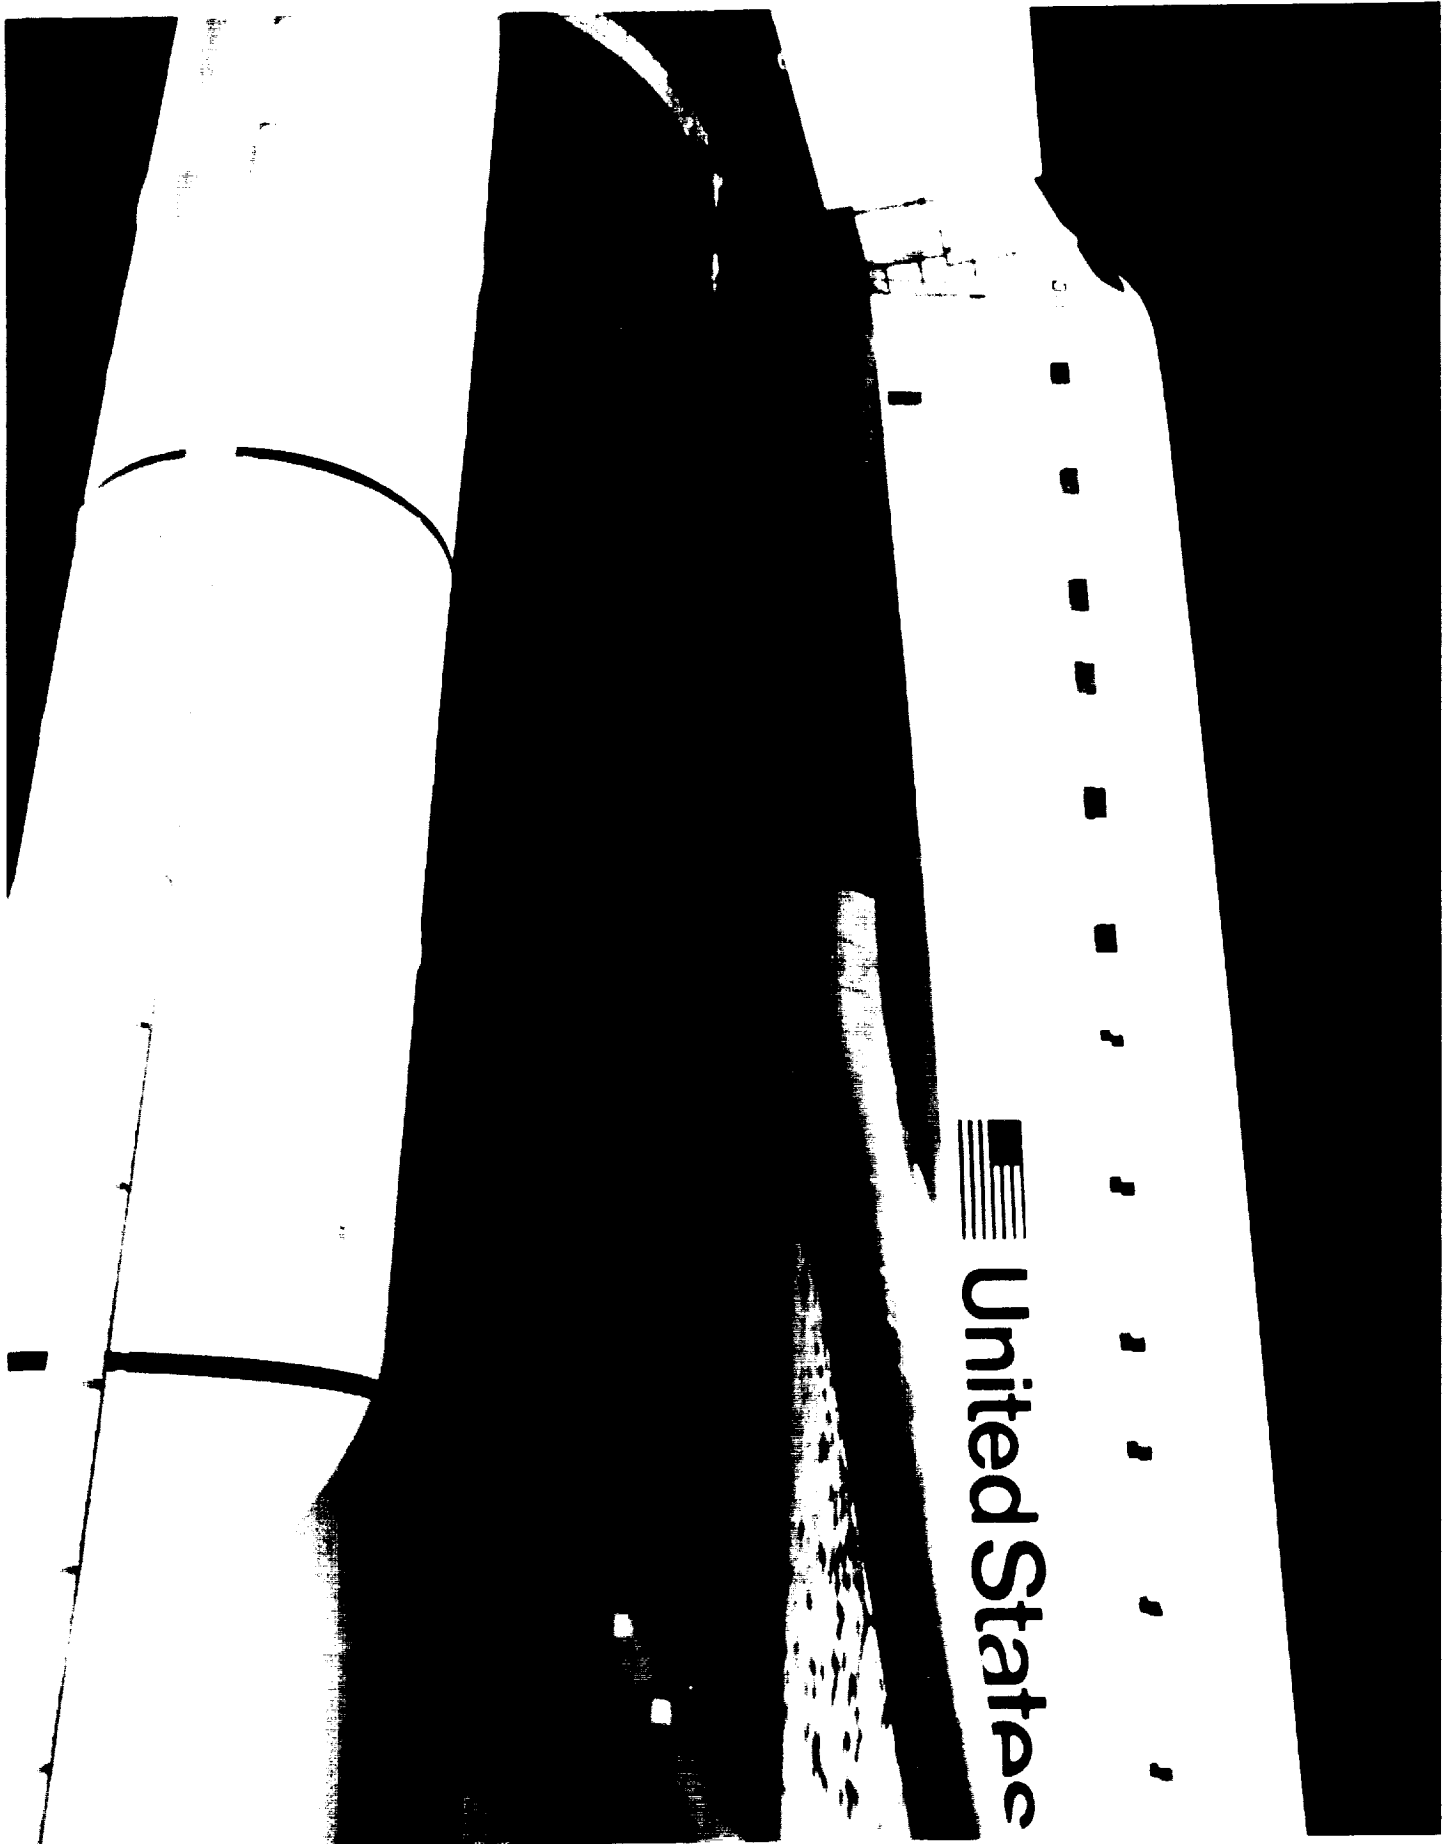
A moderate amount of condensate, but no acreage ice or frost,  
was present on the +Z side of the External Tank

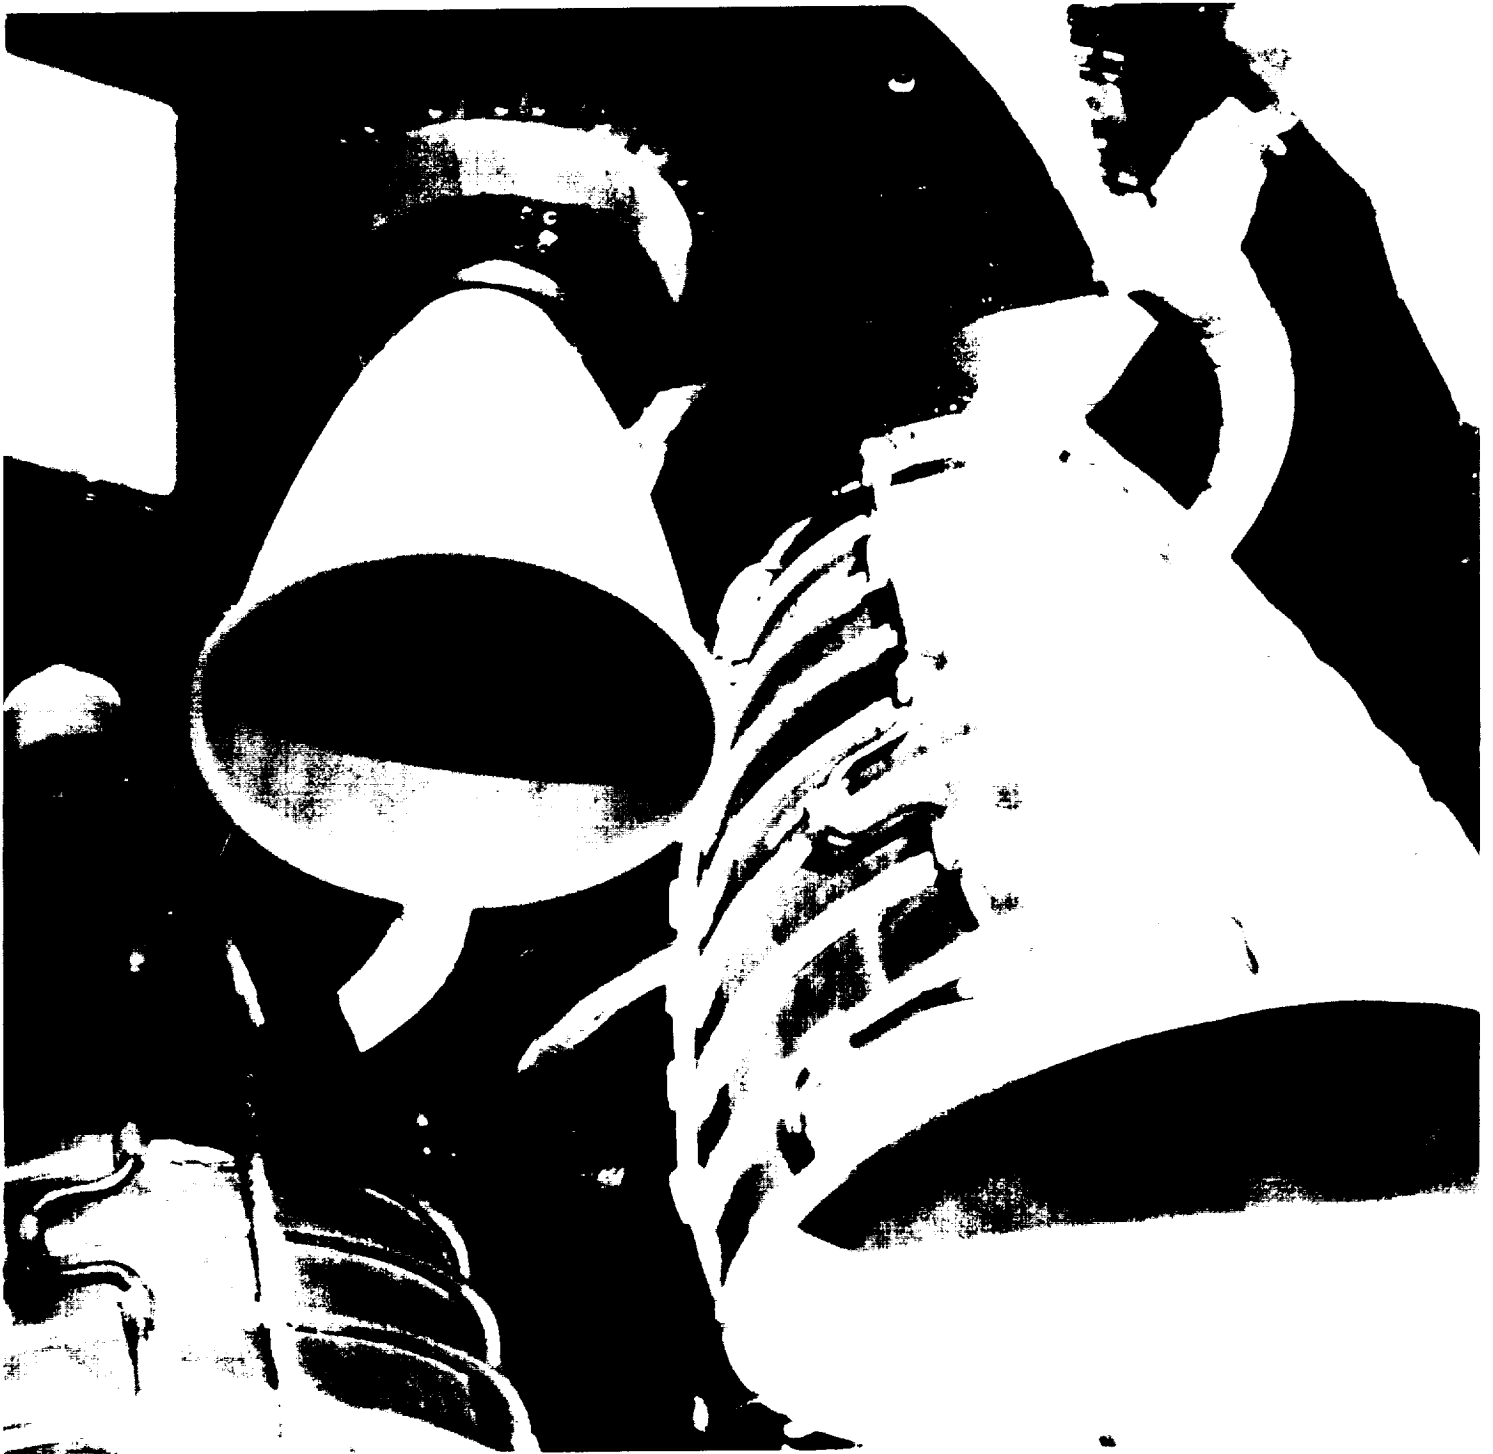
Light condensate was present on the SSME engine mounted heat shields. Light frost had accumulated on the SSME #1 and #2 heat shield-to-nozzle interfaces.

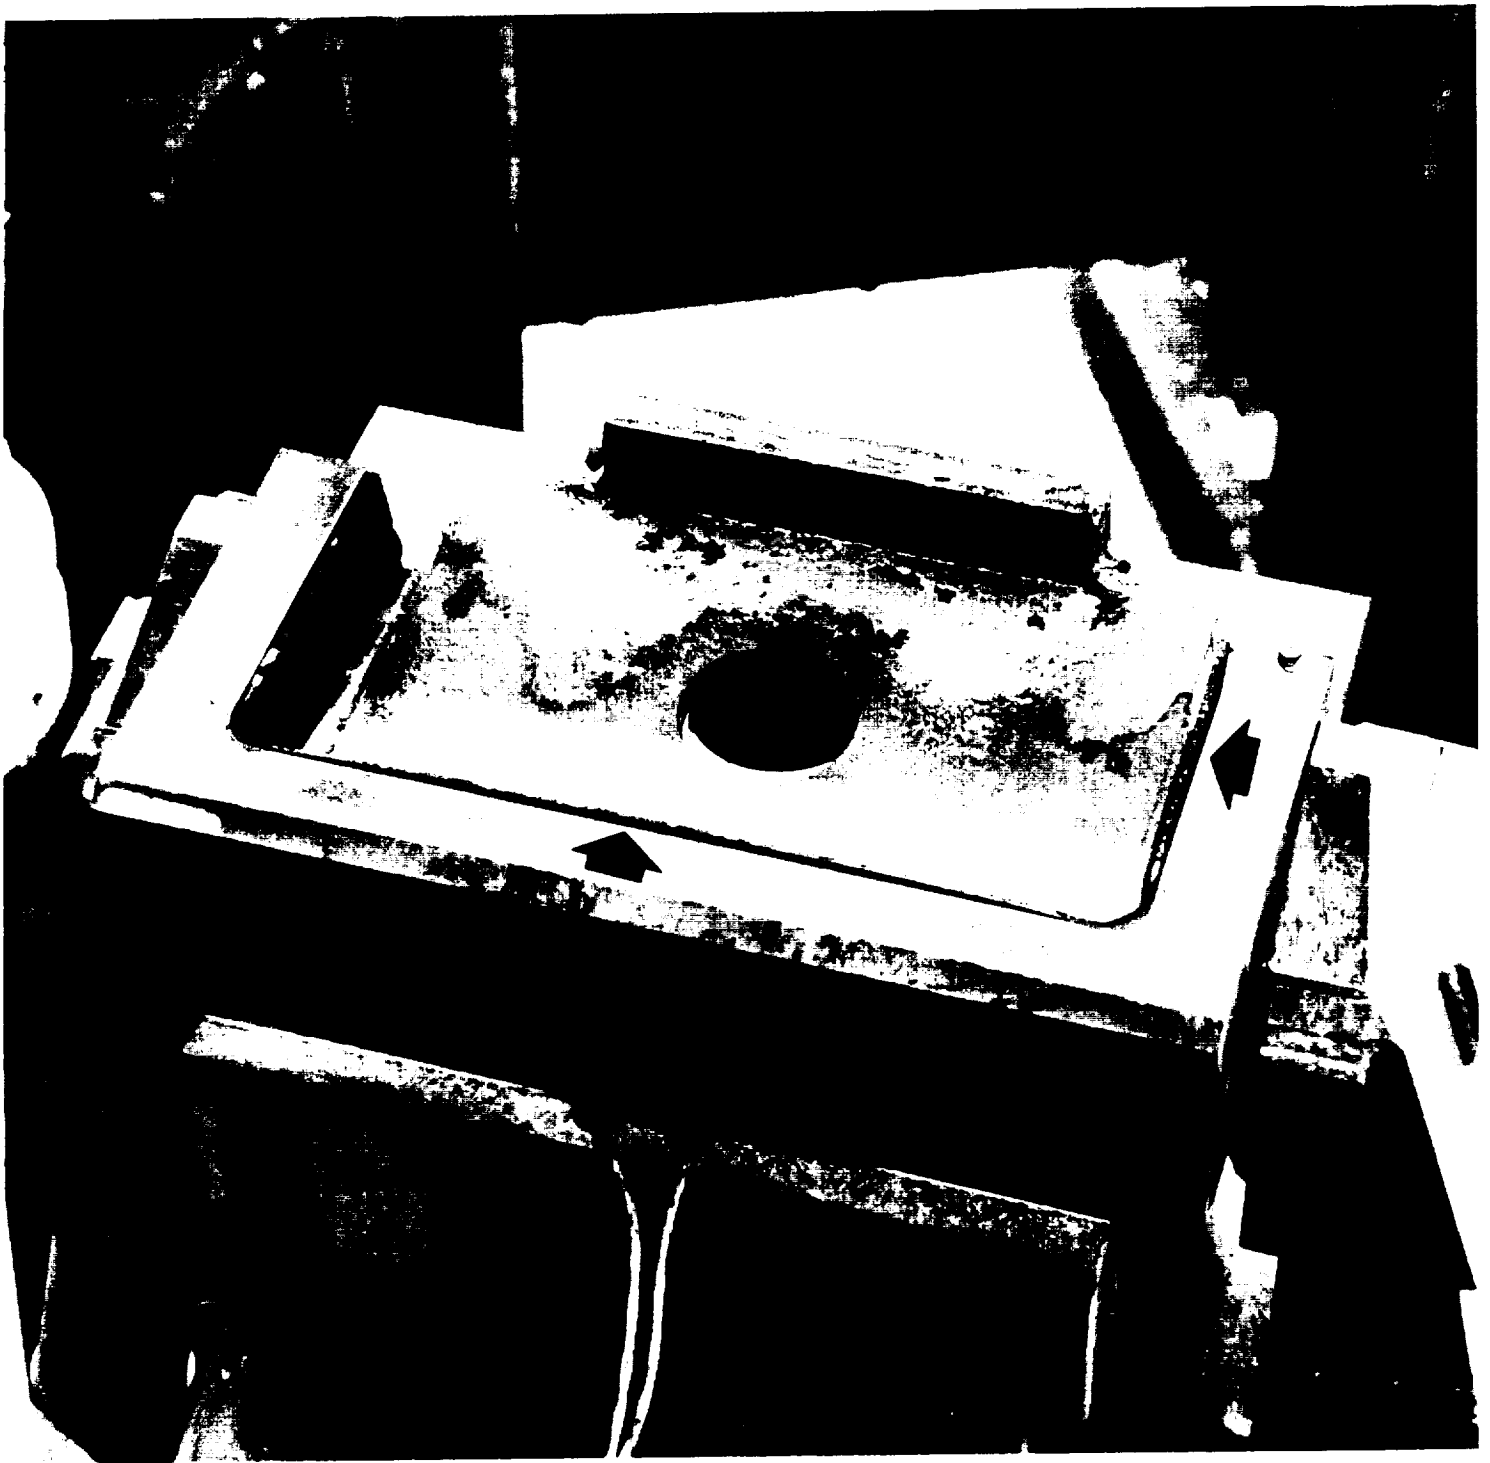
EPON shim material on the south holddown posts was intact, but the sidewall material was debonded to various degrees.

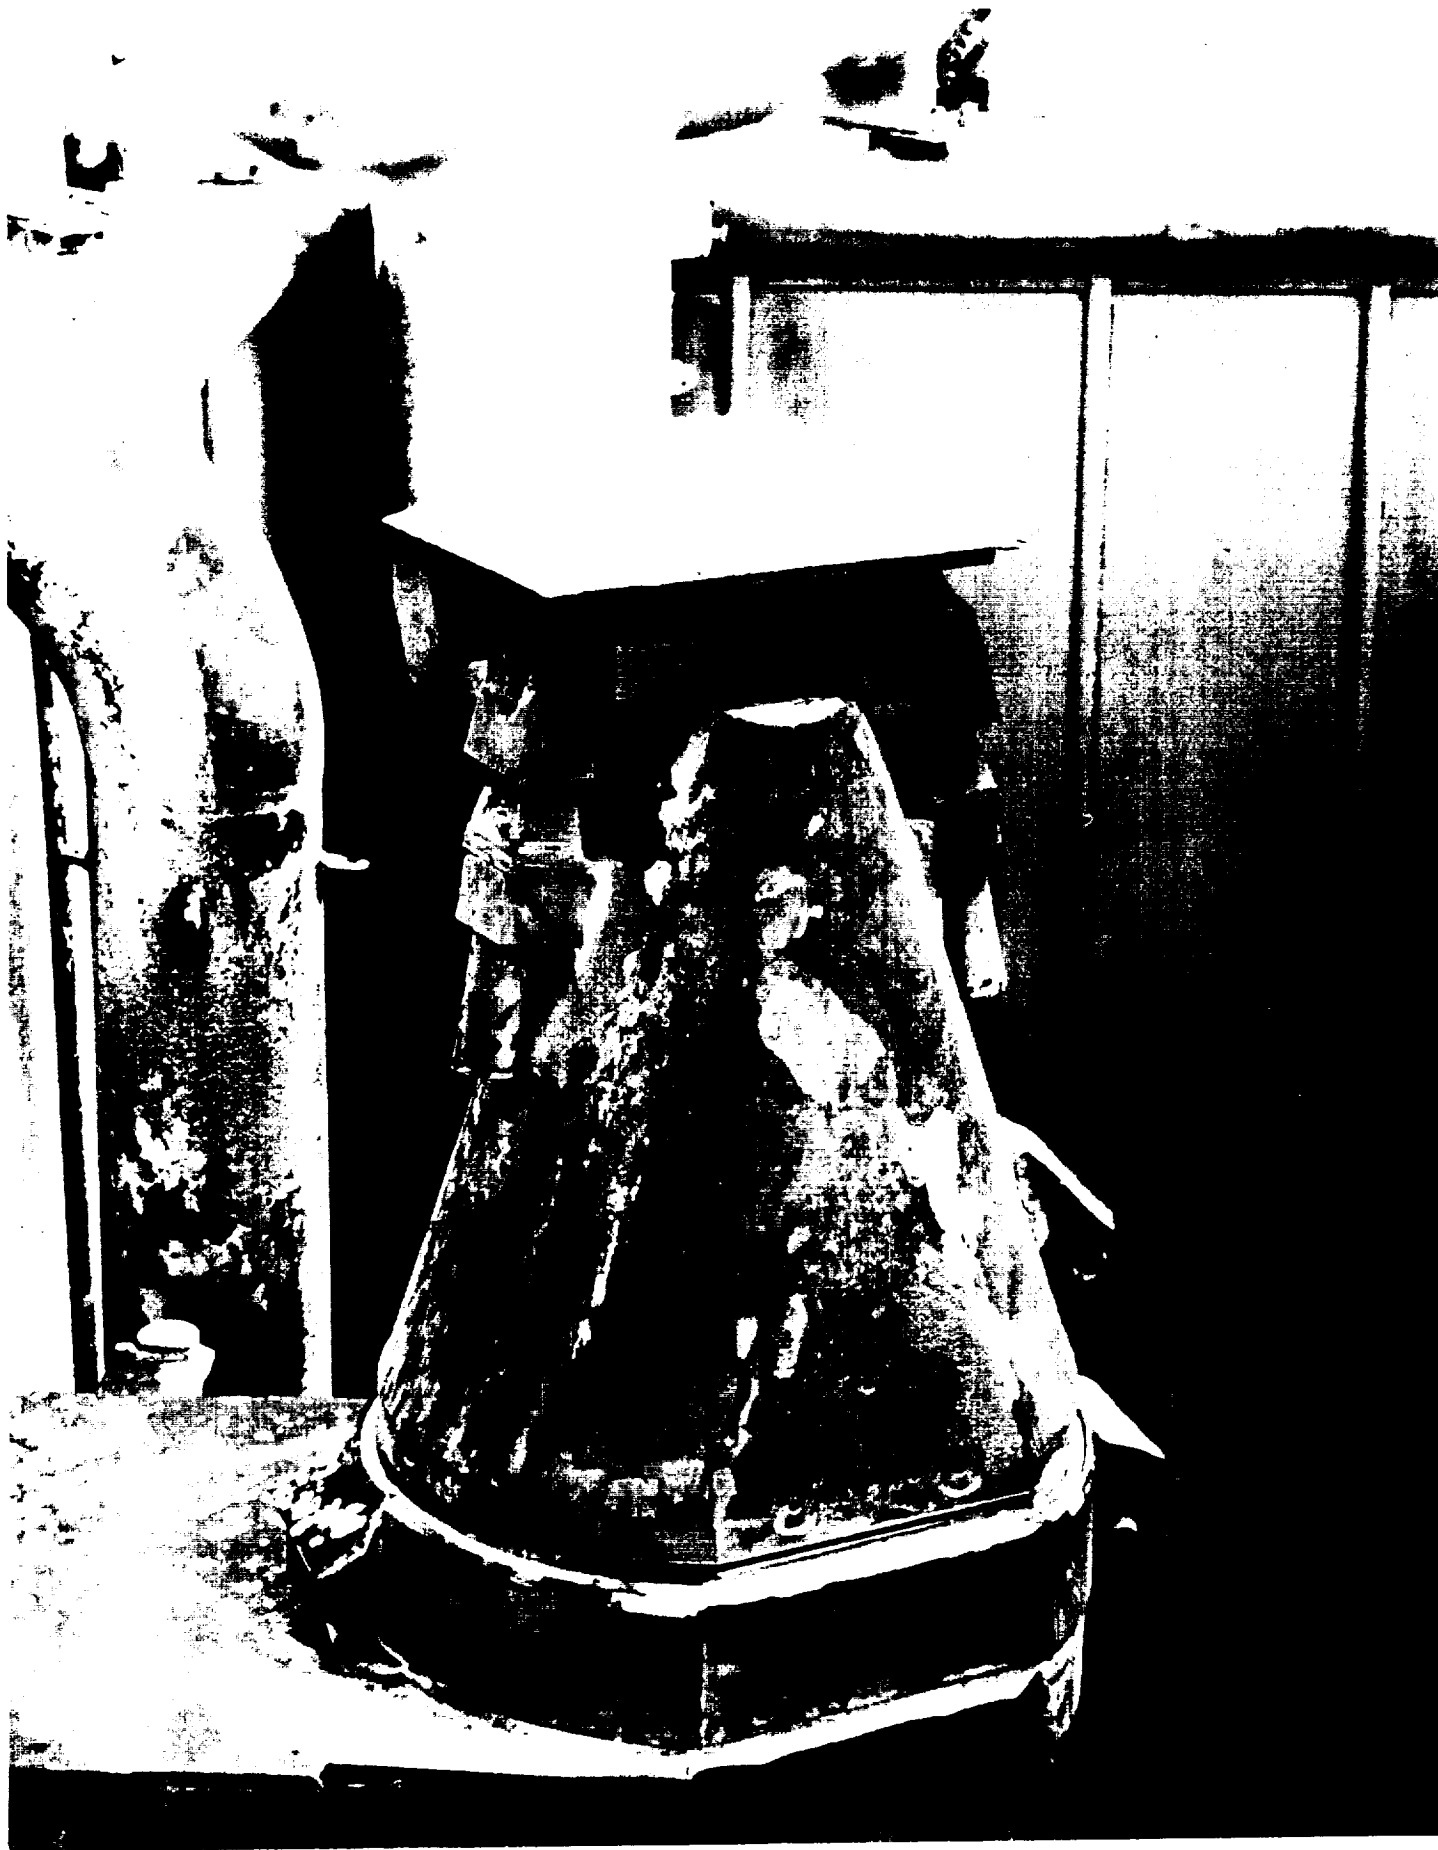
North holddown post doghouse blast covers were in the closed position and exhibited less than usual SRB plume erosion

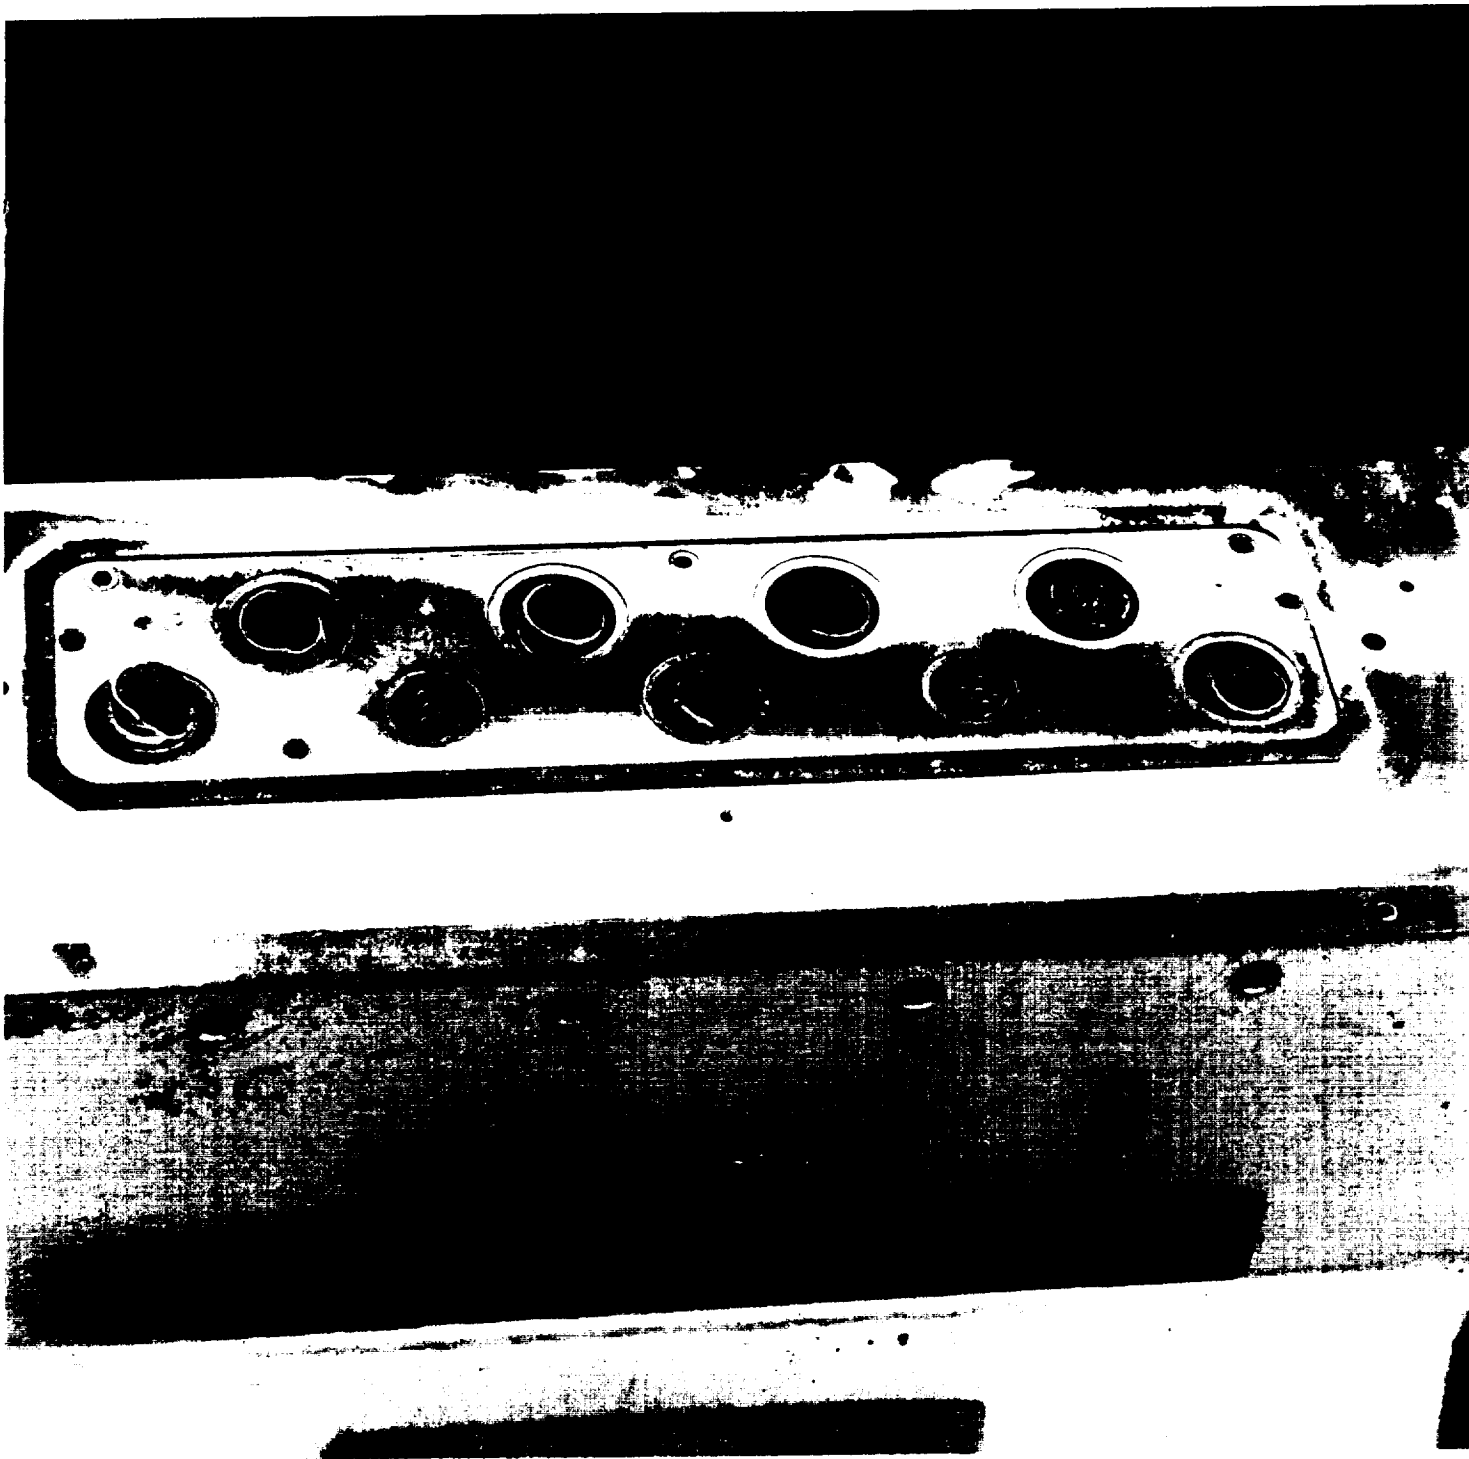
The cable connector savers (sacrificial pieces) on both SRB T-0 umbilicals showed typical plume impingement effects

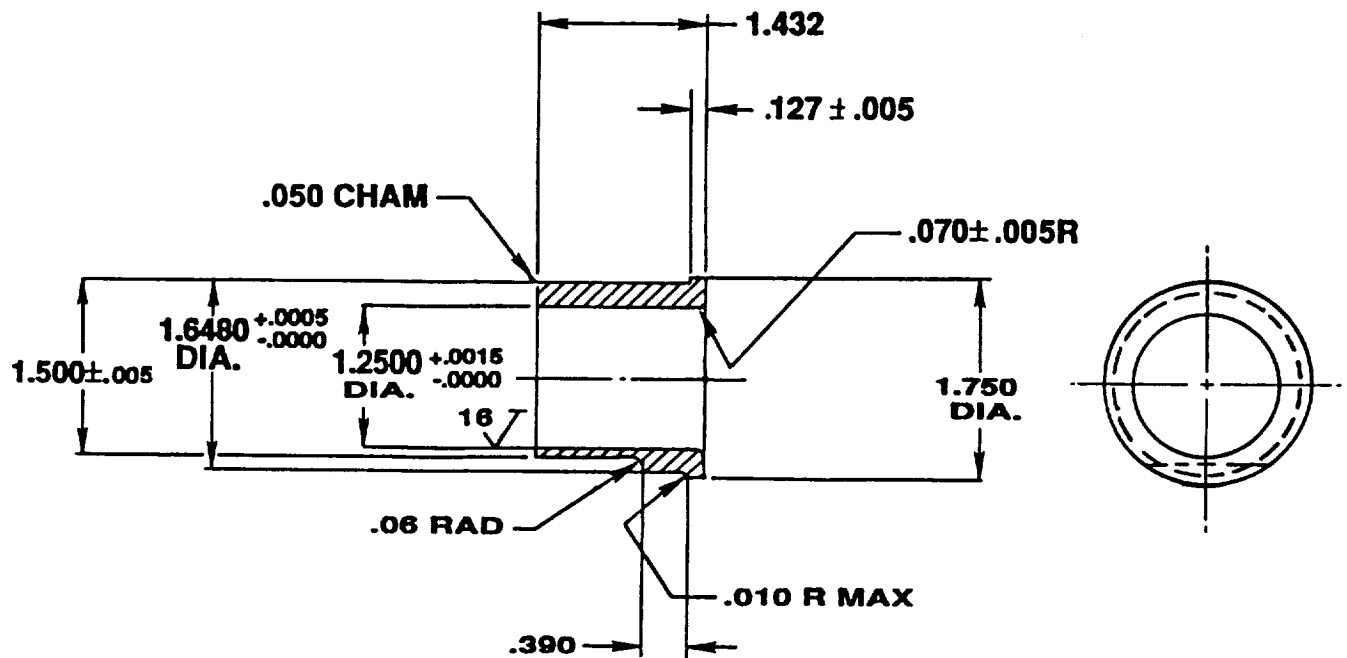
FIGURE 8.

Shortly after ET separation, the 16mm film showed a metallic cylinder drifting past the LH2 ET/ORB camera and moving away from the Orbiter. Inspection of OV-102 ET/ORB umbilicals after landing revealed no missing hardware. KSC identified the object as the outboard shear pin bushing from the ET half of the LH2 ET/ORB umbilical. Dimensions of the bushing are shown in Figure 8. On-orbit umbilical photography confirmed the inboard bushing on the LH2 umbilical and the two bushings on the LO2 umbilical were still in place after ET separation. KSC inspected the bushings on ET-47 prior to OV-104 umbilical mate. No anomalies were found. Presence of the bushings on ET-47 after separation from the Orbiter (STS-43) can not be confirmed due to lack of umbilical cameras on OV-104. The Flight Problem Report is summarized in Appendix A.

# **ET/ORB SHEAR PIN BUSHING** **P. H. DWG 5753322**

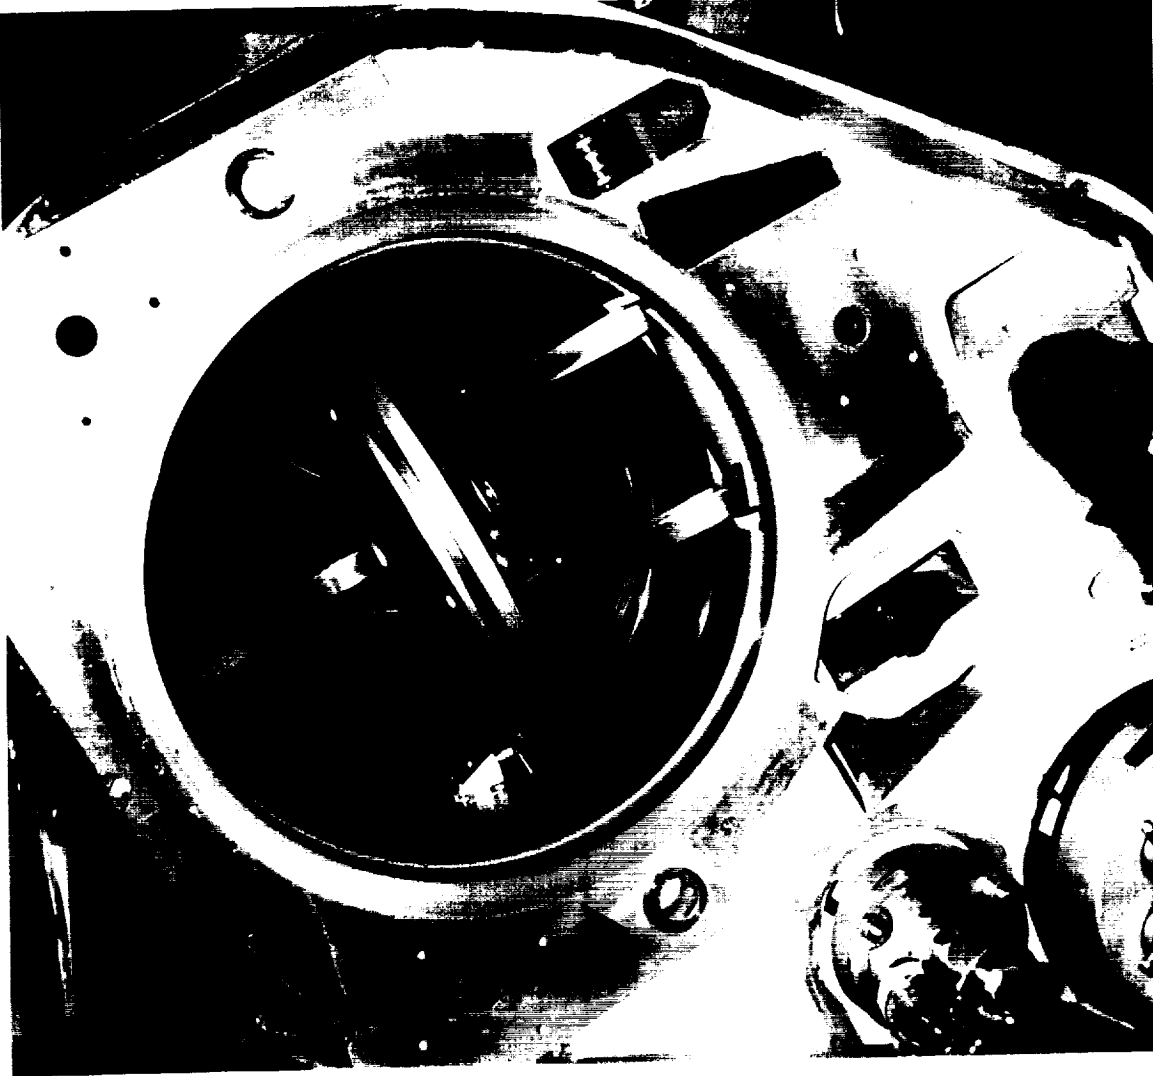
16mm camera in the LH2 ET/ORB umbilical recorded the presence of the outboard shear pin bushing/sleeve from the ET half of the LH2 umbilical. Pre-flight closeout photo shows the bushing (arrow) in the umbilical disconnect plate near the LH2 17-inch feedline.

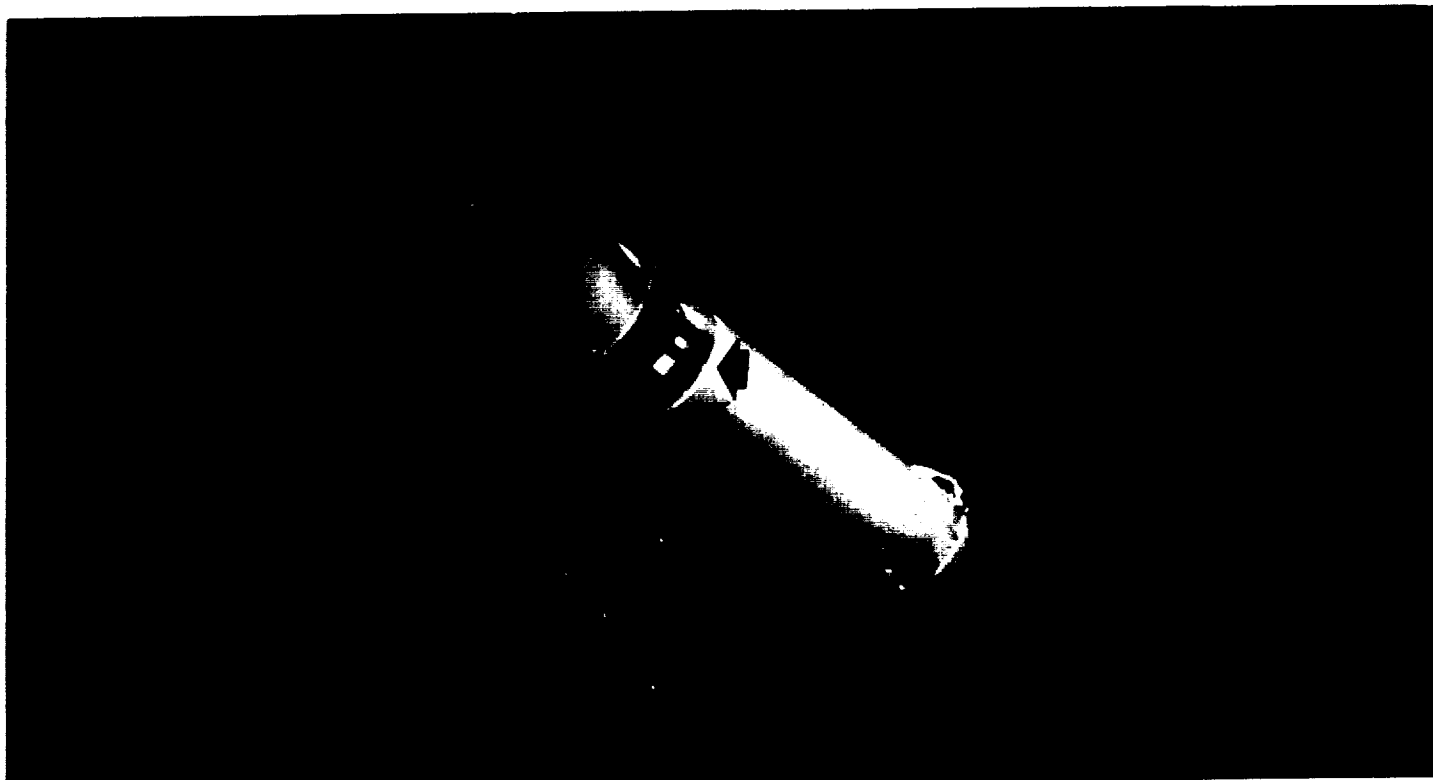
Two TPS divots, approximately 8-10 inches in diameter, were located on the LH2 tank-to-intertank flange below the intertank access door and GH2 vent line QD. There were no visible anomalies on the TPS acreage. Pieces of MPS ice reflected sun light as the ET drifted away from the Orbiter.
